Site monitoring report

Site Name: Rivenhall Airfield – IWMF site

Visit no: 1

Date: 17 April 2023

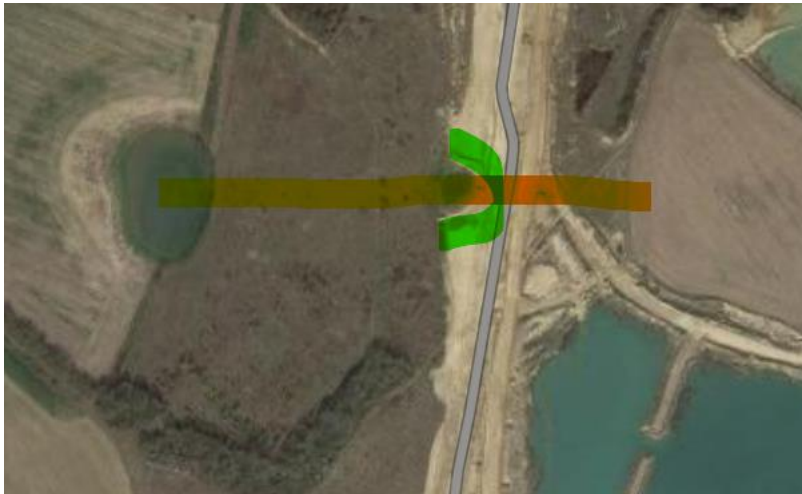
See aerial photo below for location purposes only, acknowledging that the photo may not be very recent. The connection between the drain which runs west to east from the field west of the access road and New Field lagoon appears to not be low enough to ensure the field drains fully (shown orange). Bunding was placed around the outlet when the temporary access was put in place (shown green). There should be no need for this bunding if the drainage is at an appropriate level to ensure the field drains

properly. Gareth agreed at last monitoring visit prior to access road construction this would be resolved.

These drainage issues need to be addressed.

Provide confirmation that drainage provision has been made under the access road to ensure the field NW of Maxey Spring drains to New Field Lagoon and that the agricultural drains with site R have been connected to drains flowing to New Field Lagoon.

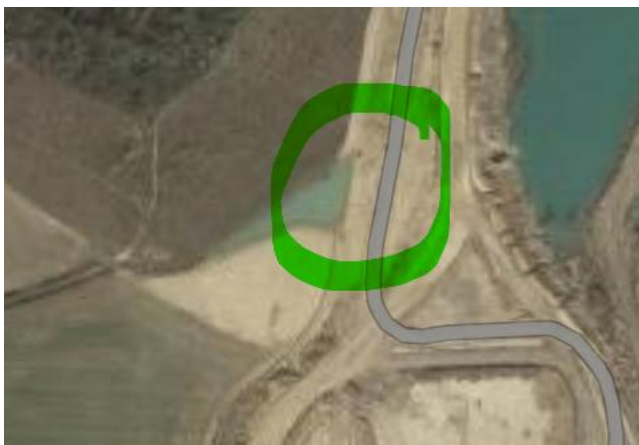
It also appears that works are required on the edge of Site R to ensure the agricultural drainage works effectively. See location below.
