# Site monitoring report

**Site Name:** Bradwell Quarry

**Operator:** Blackwater Aggregates

**Date:** 31 August 2023

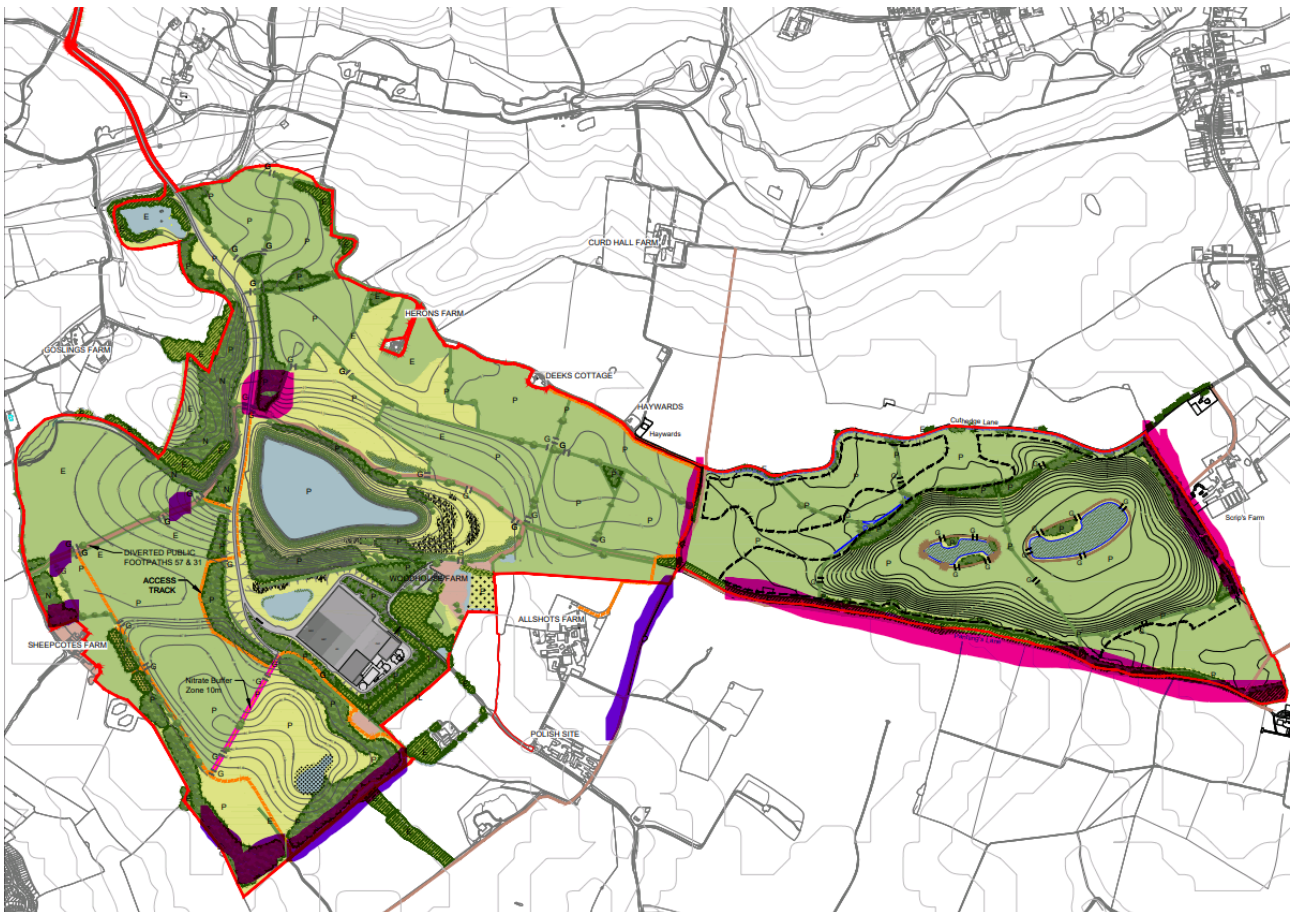
Site r Green Lane, A2, A5, A6 and A7 – Woodland/hedge planting needs beating up. See drawing below. Purple areas identified on visit. Pink areas not checked at visit but need checking and beating as necessary. Early planting of woodland south of silt lagoons requested.

Comment: PW to organise in Autumn 2023
