Site monitoring report

Site Name: Bulls Lodge Quarry, Generals Lane, Boreham, Essex, CM3 3HR

Visit no: 2 of 4

Date: 1 Sept 2023

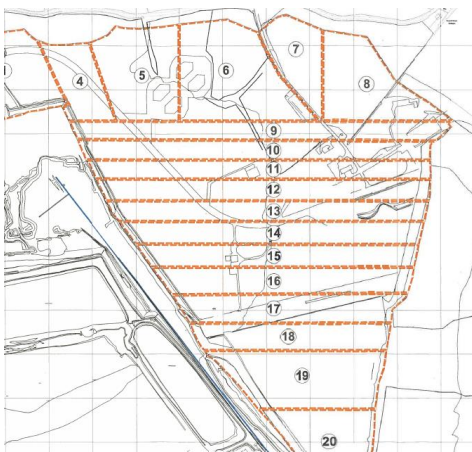
Extraction area Airfield

Northern edge of phases 5, 6, 7 and 8 to restoration levels. Phase 4 still requires some material. Areas up to restoration levels, topsoil to be placed when soils are dry.

Extraction ongoing in east end of 11, 12 and 13, nearly complete. Extraction now progressing into east end of 14, 15 and 16. Extraction not operational as repair to conveyor taking place.

Strip on western end of phases 14, 15 and 16 complete, extraction progressing into this area. Airfield tower and buildings removed ready for strip in western end 14, 15 and 16.
