# Site monitoring report

**Site Name:** Blackley Quarry, Gt Leighs, Chelmsford, Essex, CM3 1QP

**Date:** 20 March 2023

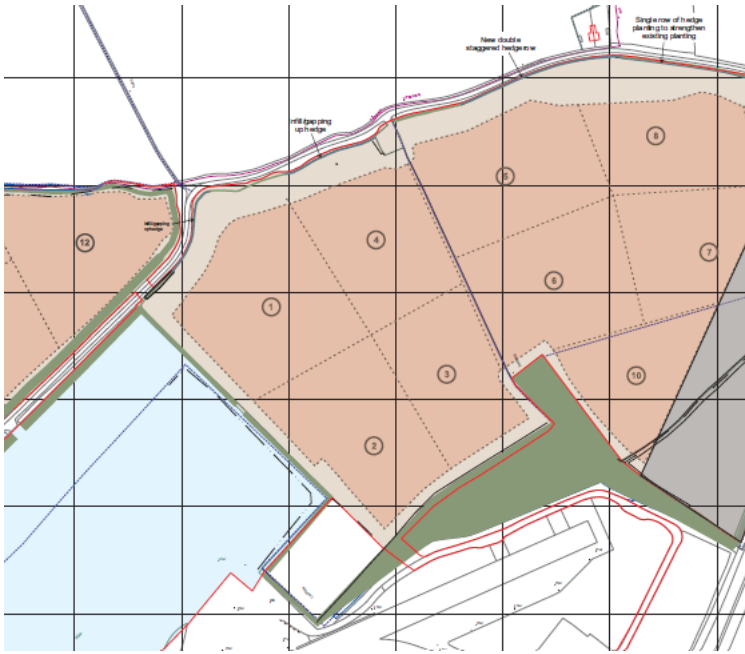
Sand stockpile in Phase 2

Stand-off to Blackley Cottages from the excavation face was being maintained
