# Site monitoring report

**Site Name:** Highwood Quarry, Stortford Road, Little Canfield

**Date:** 17 March 2025

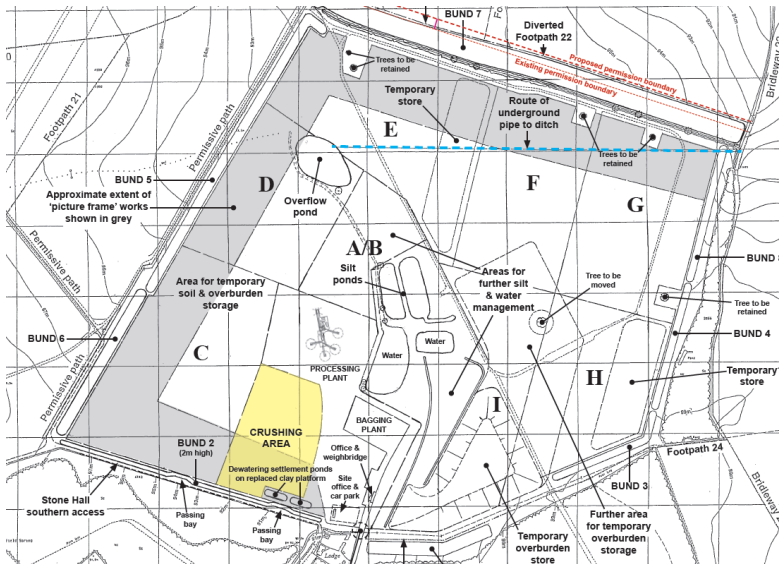
While the large bunds (east and north of site) are well maintained the western boundary is a mass of weeds, the seeds are likely to drift onto the restored area and agricultural land beyond – it essential they are strimmed to reduce weeds and improve appearance. This has been raised many times, formal action will be considered if this matter is not addressed this summer.

Screening bund on the western boundary to be maintained, weeds trimmed and then treated to suppress weeds.

Comment: No progress, formal action will be considered if no progress is made in summer 2025.
