Site monitoring report

Site Name: Rivenhall IWMF-Bradwell Quarry Access Road (separate monitoring reports are available for the Rivenhall IWMF and Bradwell Quarry)

Date: 12 June 2025

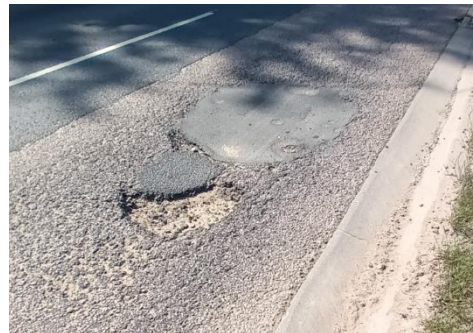
On the north bound side of the access road, just south of the Essex Way Crossing, there is a pothole that needs repair.

Repair potholes in access road.

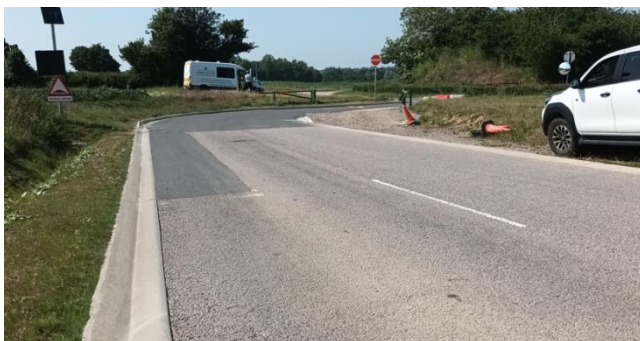
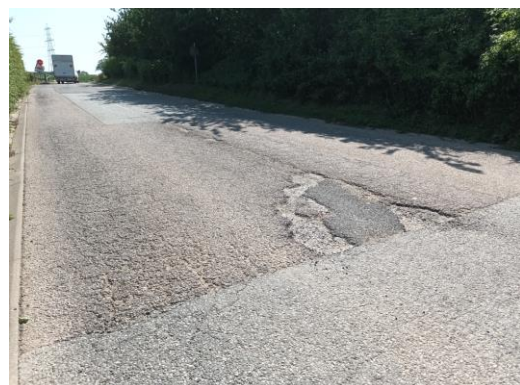
The stop lines particularly on the Church Road Crossings need repainting as they are not clearly visible.

Repaint stop lines at Church Road crossing.

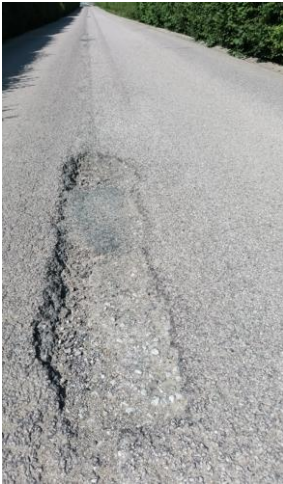
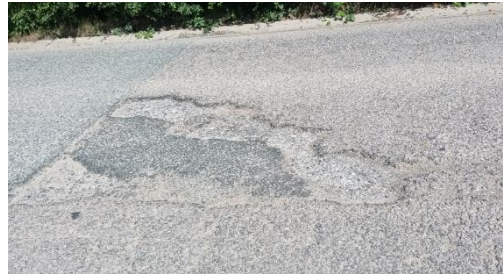
There are several areas of wear/potholes between Church Road and the River Blackwater bridge which require repair.

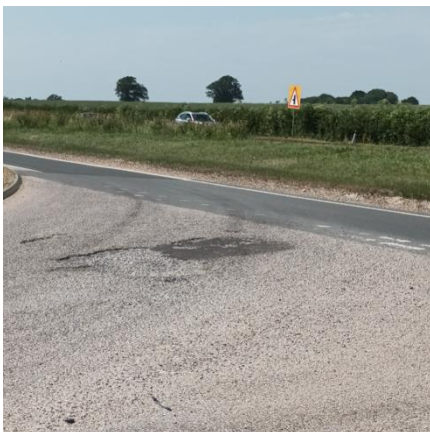
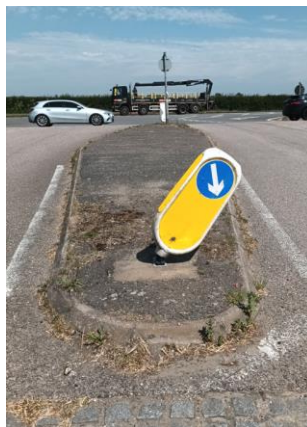
The pothole at the site exit onto the A120 needs repair again and the directional bollard has been damaged and needs replacing/repairing.

Repair directional sign at site entrance to A120.

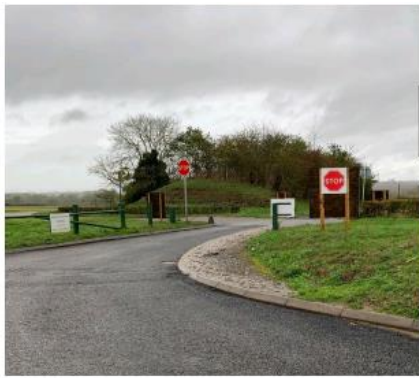
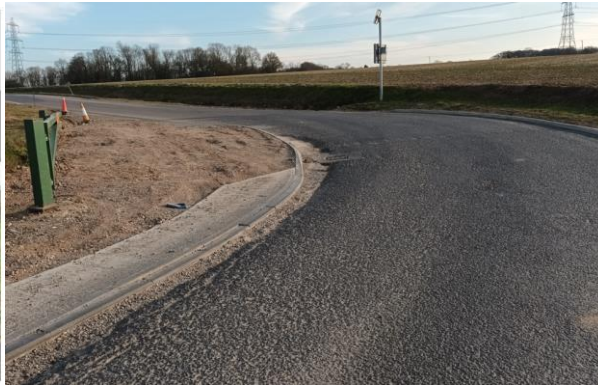
Original condition of SE Church Road Condition as of 6 March 2025

These reinstatement works I understand are planned for July 2025. The south east side of the Church Road crossings has not been reinstated to its original condition, the hard surfacing on the bend does not extend as far around the bend as previously, note the location of the drain in relation to the surfacing, and it is not in accordance with the details approved under ESS/39/23/BTE/NMA4. It has also been mentioned by Indaver that this bend may be amended, this would require a new NMA to amend the approved details.
