Site monitoring report

Site Name: Bulls Lodge Quarry, Generals Lane, Boreham, Essex, CM3 3HR

Visit no: 1 of 4

Date: 26 June 2025

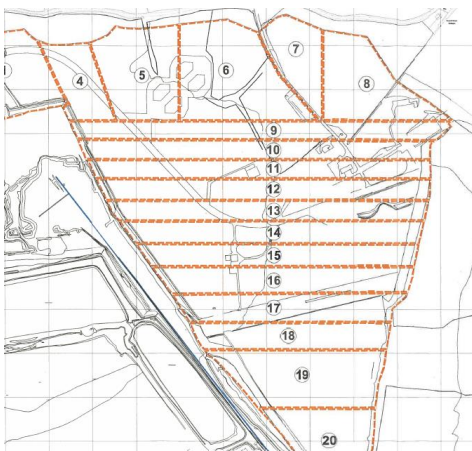
Extraction area Airfield

Extraction nearly completed in 14,15,16. Conveyor being moved to shorten length.

Phase 17 to be stripped in Sept 20025, likely extraction of mineral will take to April 2026, when operations would move to Park Farm.

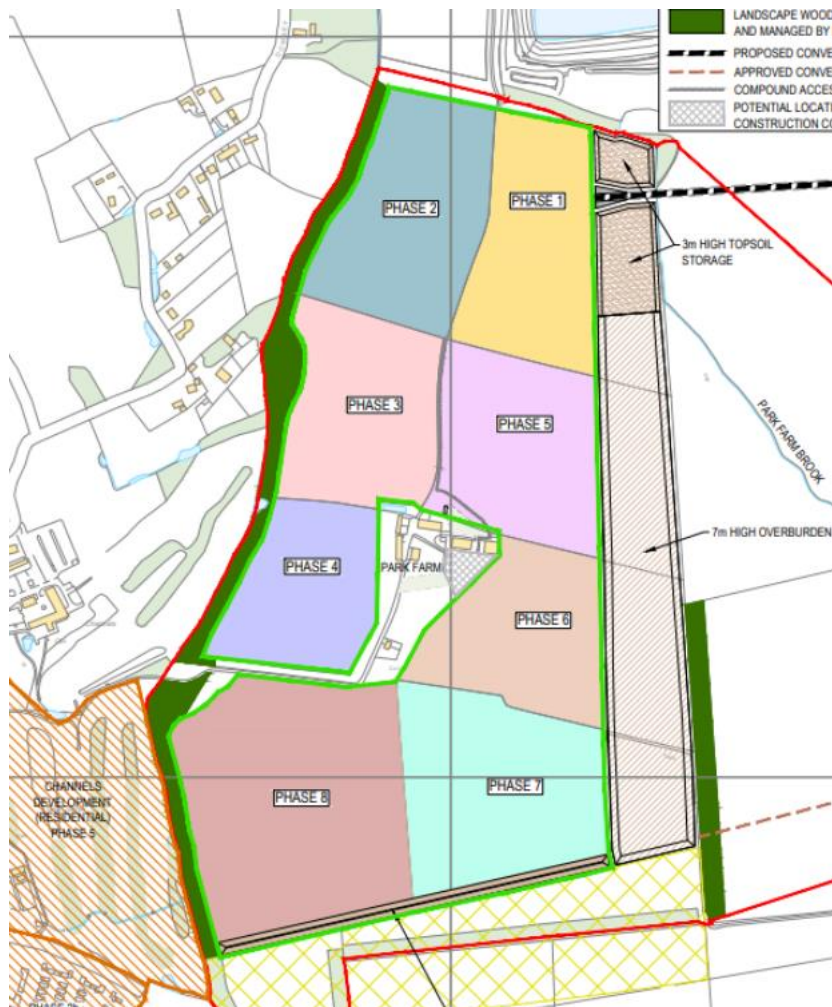
Park Farm Extraction Area

Archaeology in Phase 1 and 2 is complete and the power cable relocated.

The post excavation report for these areas is outstanding.

The Park Farm Brook is planned to be relocated in July/August 2025

Overburden removal in Phase 1 likely to commence Q4 2025 with the conveyor put in position in Q4

Archaeology planned for phases 3/4/5/6 in 2025, a WSI has not been approved by the MPA at this time. Trail trenching in Phase 3 undertaken previously, but not within remaining phases of Park Farm.
